179
Defects in Plumbing
and Drainage Work

described by Francis Vacher
upwards of 100 illustrations

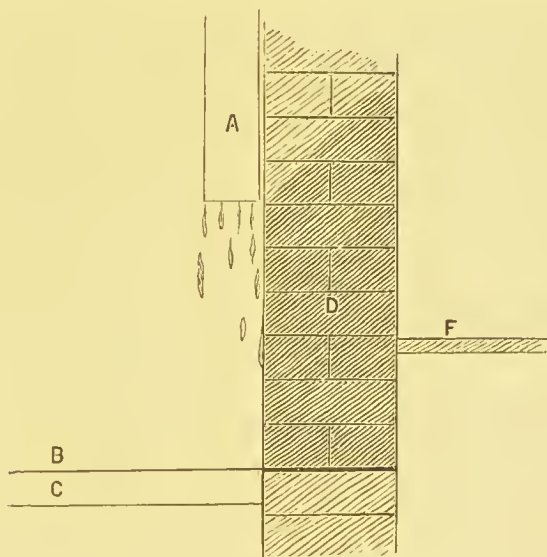
FIG. 1.

Figs. 1 and 2 illustrate the negligent way in which rain spouts are fixed, and the resulting nuisance from damp. The examples are taken from two new houses in a new street.

Fig. 1 shows the rain spout terminating 18in. above the surface of the pavement, and consequently discharging large quantities of rain directly on the wall of the front parlour.

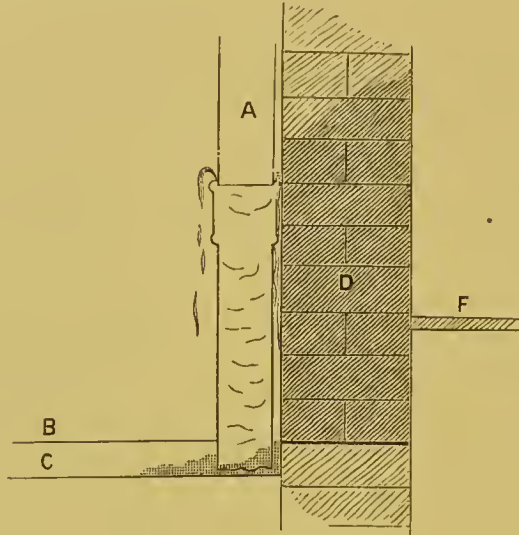
FIG. 2.

Fig. 2 shows the spouting continued by a length which has been broken off too short, and fastened too low. The end being

deep down in the rain-water conductor in the pavement, sooner or later becomes choked, and then the water overflows at the first joint. As the end of pipe A was only within the socket of the pipe below for $\frac{1}{8}$ in., and the joint was quite open, there was nothing to check the discharge of rain on the wall. In both

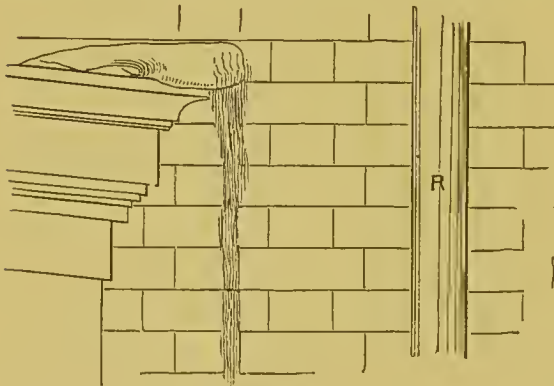
FIG. 3.

Figs. 3 and 4 represent defects lately brought to my notice in a row of new buildings. The bay windows in the front of four small houses have the rain conducted from the roofs, as shown in Fig. 3. In each house a piece of lead, cut too large for the window, is rolled up one side, and conducts the rain on the front wall, where it has already left a large stain. A rain spout R, terminating in a channel in the pavement, passes close by. The bay windows in front of the remaining six houses in the same row have the rain conducted from the roofs as shown in Fig. 4. The lead-covered roof of each window is provided with a short lead pipe, which pierces the coping stone, and delivers, as shown, like a watering pipe.

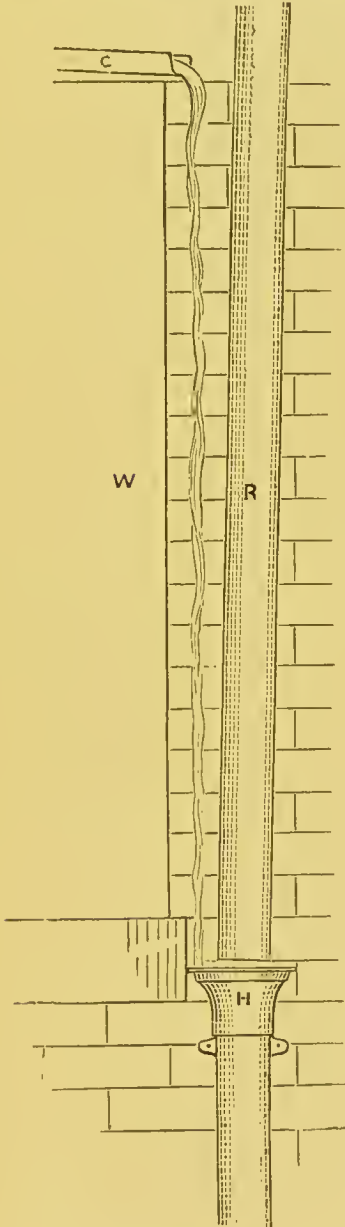
FIG. 5.

Fig. 5 shows a clumsy arrangement for carrying off the rain from a house. C is the termination of a rain gutter, gathering from upwards of 130 square feet of slates. Instead of being conducted to the rain spout R, gathering from another part of the roof, it discharged into a rain-spout head H, $5\frac{1}{4}$ ft. beneath, causing a nuisance from damp along the wall by the side of the window W, and splashing at the corner of the window close to H.

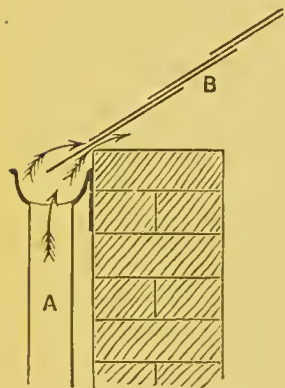
FIG. 9.

Fig. 9 is the section of the top of a wall, the slates, and rain gutter, and shows how a rain spout, carried straight into the drain, delivers gases from the drain into the house. To simplify the illustration, the framework of the roof is not indicated. B is where this framework would be; A is the 3in. rain spout made of sheet iron, and well jointed and connected to the gutter; and the arrows show how the gases find their way under the slates into the house.

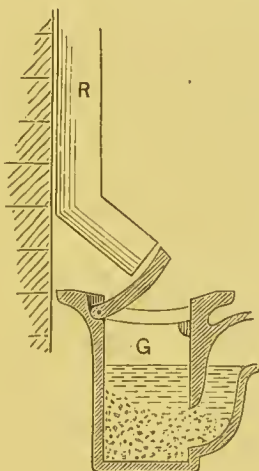
FIG. 10.

Fig. 10 illustrates a defect I saw recently, and I have frequently seen similar defects in sink-waste disconnections. In a detached villa in the suburbs the rain spouts are brought down to deliver on gully traps, in the manner shown. The grating of the trap is hinged, and made to open to a right-angle with the mouth of the trap, in order to allow of the trap being systematically cleansed. The end of the rain spout is fixed so close to the trap that the grid cannot be opened except to an angle of about 35 degrees, and the result is that it is almost impossible to cleanse the trap efficiently. As the rain spout is cast iron, the outflow of the trap is almost choked with rust. R is the rain pipe, and G the gully trap.

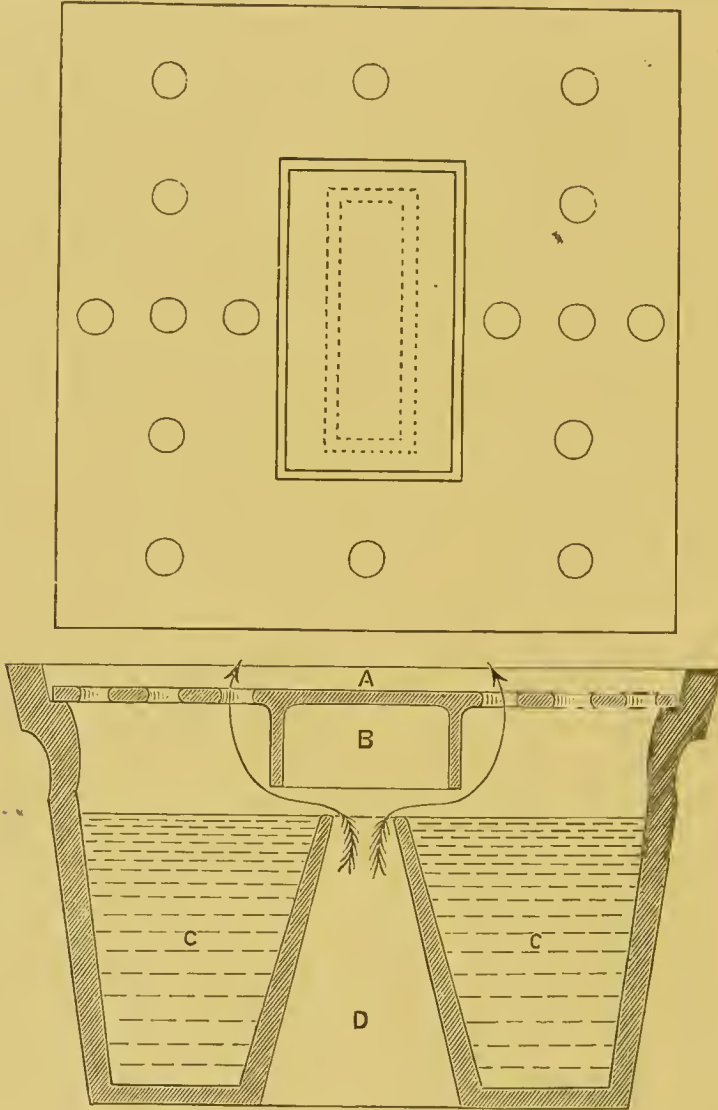
FIG. 12.

Fig. 12 represents a so-called box trap. When discovered, it was supposed to be trapping the yard drain belonging to a house in an important thoroughfare in the centre of the town. The sketch is half the size (linear) of the original. In the section, A is the lid, perforated with sixteen small holes, and carrying the useless box B on the under surface; C is the reservoir of water $2\frac{1}{4}$ in. deep, into which the box should dip, but which it does not touch; and D is the outflow from the trap leading to the drain. The upper part of the cut represents the lid turned upside down, the inner dotted line being a plan of the mouth of the trap outflow. The trap is of cast iron, and in all probability hundreds of the same casting have been sold.

had set the trap quite square, and made good connections, he was not to blame. This is to take a very low view of a workman's duties. The primary defect was certainly in the casting, but surely no intelligent workman does his duty who fixes a trap without first testing it.

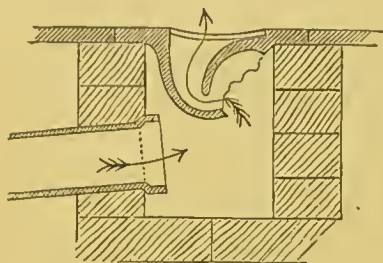
FIG. 17.

Fig. 17 represents the trapping of a yard drain as done by a local tradesman. A notice had been served on the owner of a small cottage dwelling to provide a properly trapped yard drain

and I called to see if the work had been done. The tenant said the workmen had finished the job a day or two ago, and took me into the yard. Here was the new glazed earthenware trap, but as it did not hold water, even when freshly poured in, I had

it removed. There was a large hole in the back, as shown in the cut. I questioned the tenant as to whether anyone belonging to the house had removed the trap and broken it, and he said the trap had not been touched since the workmen left. The only course open to me, therefore, was to believe that

a tradesman had been guilty of the fraud of selling and fixing a broken trap.

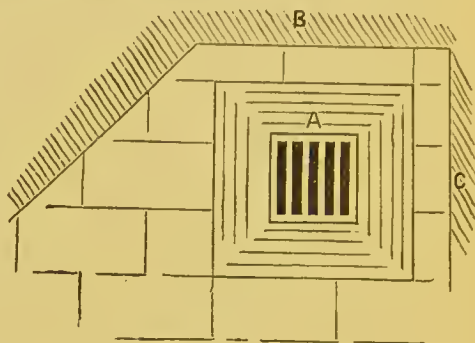
FIG. 18.

Fig. 18 shows a dummy area drain. Damp was complained of in the front wall of a kitchen. The area was paved with brick, and in the corner where the damp was noticed was a

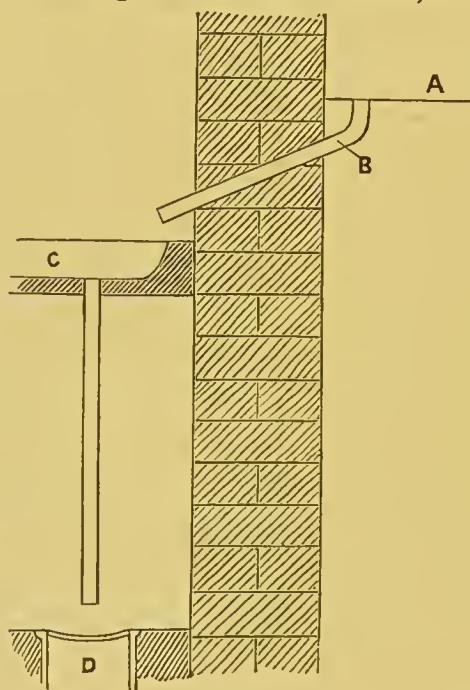
FIG. 19.

Fig. 19 is the section of the wall of a back kitchen. A represents the bottom of an area, C a sink-stone, and D a trap for the back kitchen drain on which the sink waste pipe discharged. Instead of draining this area in a proper way it was drained to the sink-stone by a short lead pipe B. What first led to this part of the house being examined was an effluvium nuisance in the back kitchen, which was traced to the trap D. The trap was obviously sealed with a decomposing animal liquid, and the readiest explanation of this seemed to be that the area had been used after dark for a purpose for which it was certainly not intended.

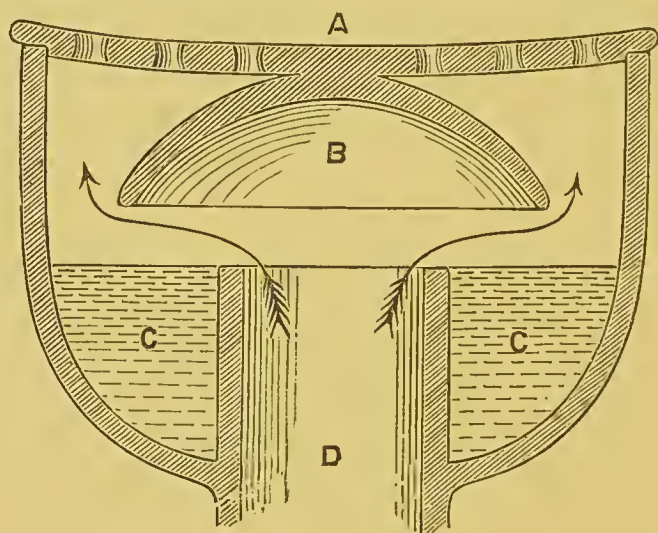
FIG. 20.

Fig. 20 shows a typically bad bell trap I discovered in the scullery of a house rented at £30. I examined it with great care, and then drew the section given, the exact size of the original. A represents the perforated grating, B the bell, CC the water reservoir—which the bottom of the bell never could have reached—and D the portion of the trap which was continuous with the sink waste that went straight into the drain. It will be seen that the whole apparatus is simply a pretence,

the depth of the bell at the centre being barely half an inch, and the distance between the bell rim and the surface of the water being just a quarter of an inch. On the same day, in the same street, I examined a sink bell trap in another house, and found the

depth of the bell at the centre three-eighths of an inch. These were not traps the bells of which had partly corroded away by means of the action of water on iron, but nearly new traps, absolutely useless when fixed.

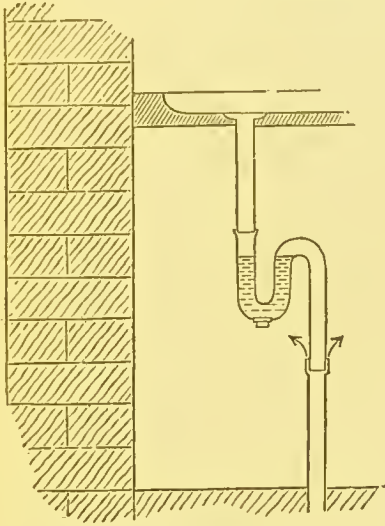
FIG. 21.

Fig. 21 indicates a sink waste pipe and its trap to which my attention was called. Being in a dark corner, it at first appeared to be a satisfactory fixing, but when closely examined it was

found the sink had a *movable trap*. The pipe to receive the lower end of the trap had been bulged out for barely an inch, and in this the lower end was placed, there being no trace of a joint of any kind having been made. The upper part of the trap had been widened out for a quarter of an inch, just enough to retain the trap in position. I have no doubt the trap had been fixed in this way to allow the tenant to clean it out at pleasure, but this was quite uncalled for, as there was access to the trap at the bottom of the bend, in the usual way. It is needless to say the arrangement was worse than having no trap at all, as it gave the householder a false sense of security. The arrow heads in the cut show that the trapping water trapped nothing.

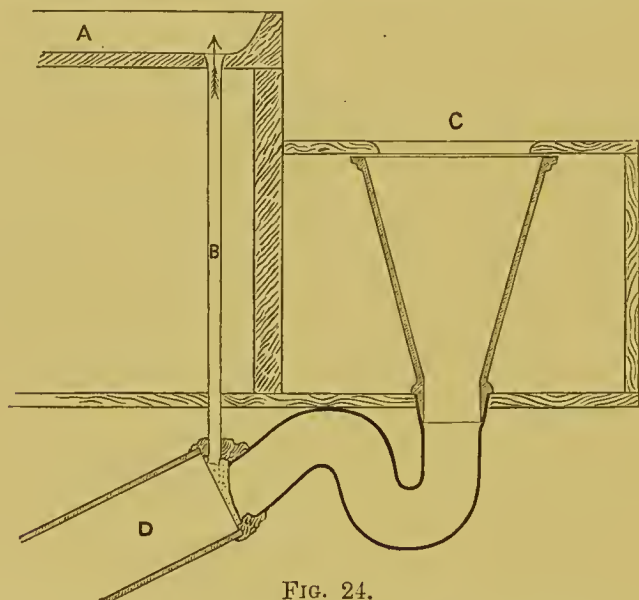
FIG. 24.

Fig. 24 represents a sink-stone and water-closet, which were placed side by side, as shown, within a scullery. The water-closet was *without water supply*. The closet basin was placed

over a syphon trap, which would frequently become choked, and this syphon trap and the sink waste were connected to a 6in. earthenware drain. A is the sink, B the untrapped waste pipe, C the closet, and D the drain.

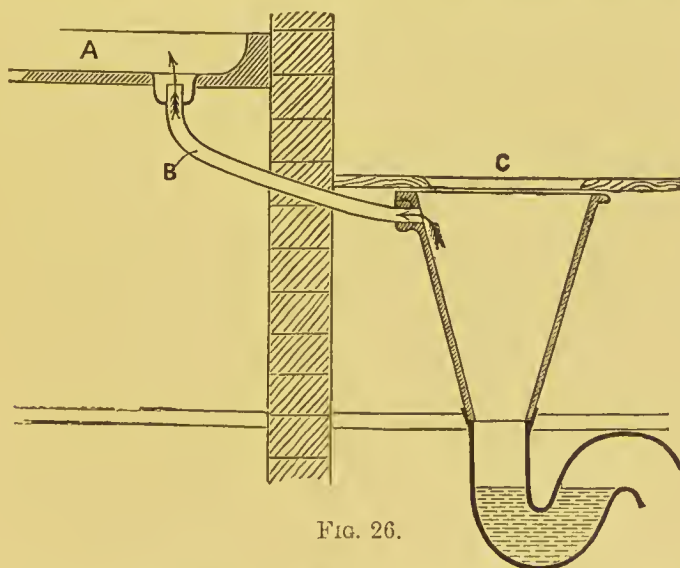
FIG. 26.

Fig. 26 shows an arrangement rather less dangerous to health and life than the one just referred to, but still horribly disgusting. A is a sink-stone, the waste pipe B of which is directly connected to the basin of closet C adjoining. The

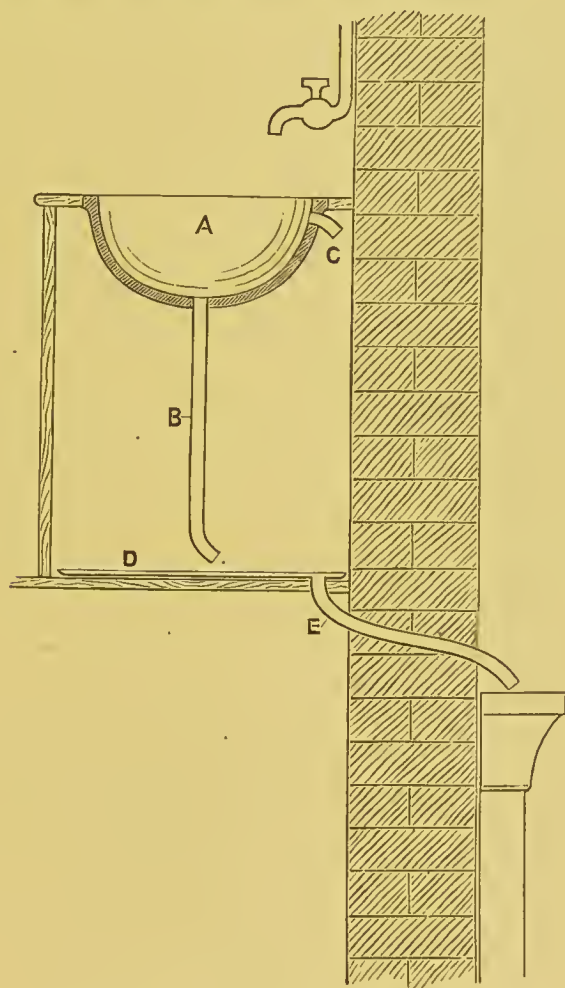
FIG. 30.

Fig 30 has been sent me by a correspondent, who writes me that he recently saw a lavatory basin as shown. It is in his experience a unique way of treating a waste pipe and overflow. The sketch explains itself. A is the basin, B the waste pipe from

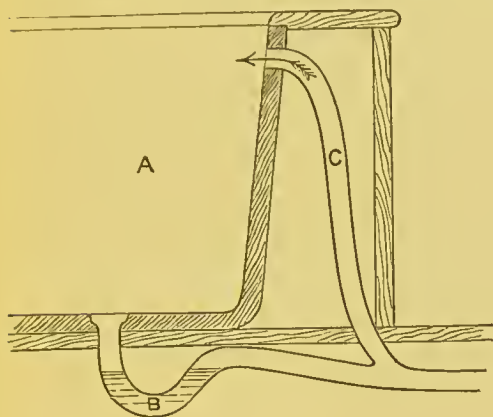
FIG. 32.

Fig. 32 illustrates the danger of an untrapped overflow pipe. A whole family occupying a house in a large town had been suffering from a low type of sore throat. The patient most severely affected had been making use of the bathroom as a bedroom. An examination of the premises, instituted by the medical officer of health, led to the discovery that though the bath waste pipe was trapped, the overflow pipe had been connected to the waste pipe between the trap and the house drain. Thus the overflow ventilated the drain into the bathroom. A is the bath, B the bath waste trap, and C is the overflow pipe.

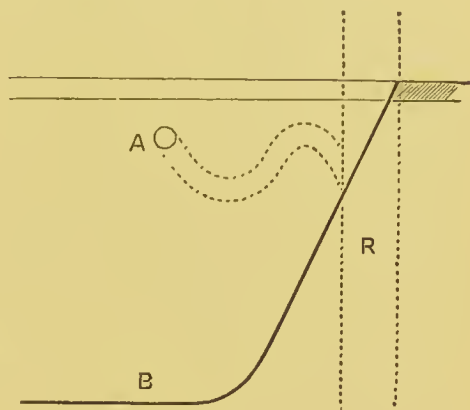
FIG. 33.

Fig. 33 shows in section the upper end of a bath B, situated against an outer wall. There was an overflow pipe at A, taken straight out through the external wall along the outside towards a rain spout R, into which it delivered. Before being connected with the rain spout it was bent downwards and upwards so as to

form a U trap. The rain spout was directly connected to the drain, and the U trap was empty, so that effluvia and noxious gases from the drains were conducted into the house and delivered close to the face of anyone using the bath. Of course,

when the bath was being used the bathroom would be unusually warm, and abundance of foul air would be drawn up. It is needless to point out that a bath overflow pipe should be disconnected. Twisting the pipe in the form of a U trap is of little service, as a bath is rarely filled so full as to bring the overflow into use.

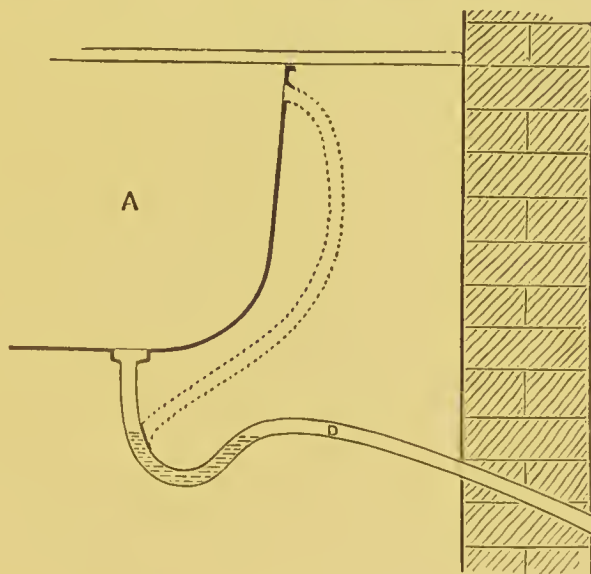
FIG. 34.

Fig. 34 illustrates a familiar defect. In a suburban villa (rent £85), lately built, the bath was found by the tenants to be without an overflow pipe. The bath waste pipe was trapped, and taken out at once, and delivered on a gully trap, and the other sanitary arrangements appeared to be satisfactory. A represents the bath and D the waste pipe, and the dotted lines indicate the position of the overflow pipe which should have been fitted.

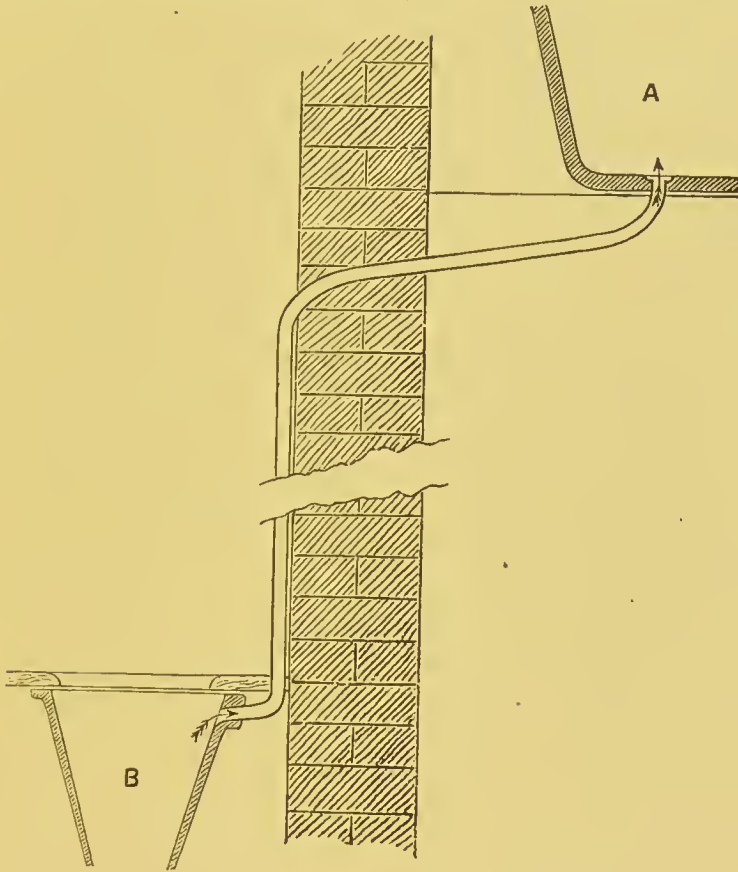
FIG. 36.

Fig. 36 requires little explanation. It represents work carried out by a competent plumber at his own house. A is a bath inside the house and B is the basin of a closet in the yard. These, it will be seen, are directly connected, the waste pipe from the bath being made to flush the closet. There was no other provision for flushing the closet, and as the pipe was untrapped, the foul air from the basin ascended to the bathroom, causing an effluvium nuisance.

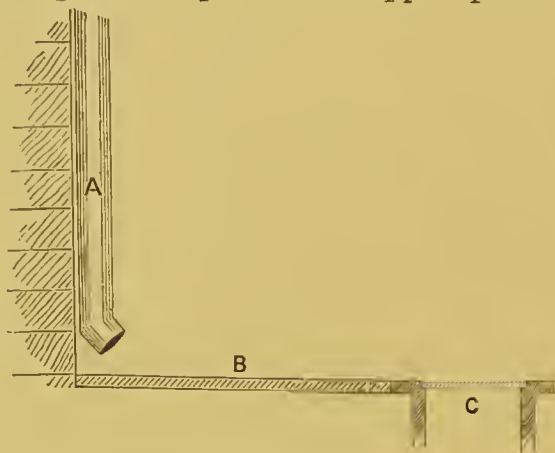
FIG. 37.

The method of delivering waste water represented in Fig. 37 is, I regret to say, not uncommon. The bath and hand-basin waste pipes are brought outside to discharge on the area flags, which are channelled to conduct the water to a trap. Only one waste pipe is represented in the cut, but I have seen three together treated in the same manner. I have also seen the trap a yard or more from the end of the pipe; and sometimes no

channel or conductor to the trap is provided. In any case the result is a nuisance from the foul state of the flagging between the pipe and the trap, and effluvia commonly find their way into the house at the kitchen or pantry window. A is the waste pipe, B the area flagging, and C the trap.

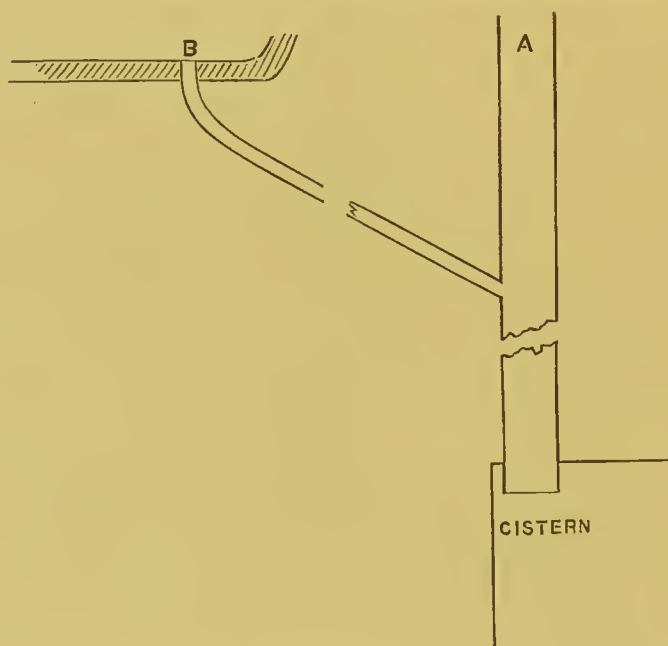
FIG. 38.

Fig. 38 is from a correspondent. He writes: "During my inspection of the sanitary arrangements of an empty house of considerable dimensions, I found that a new bath had been fixed some six or seven months prior to my inspection, and the waste pipe from same connected to a rain-water downpipe, running

close by, for convenience. It seemed to me that the rain-water pipe was in communication with a tank under the house, some distance away, and accordingly I gave instructions for opening the tank, with the result I anticipated. The bath had been in use for three or four months before the house was vacated." In the figure B is the bath and A the rain pipe.

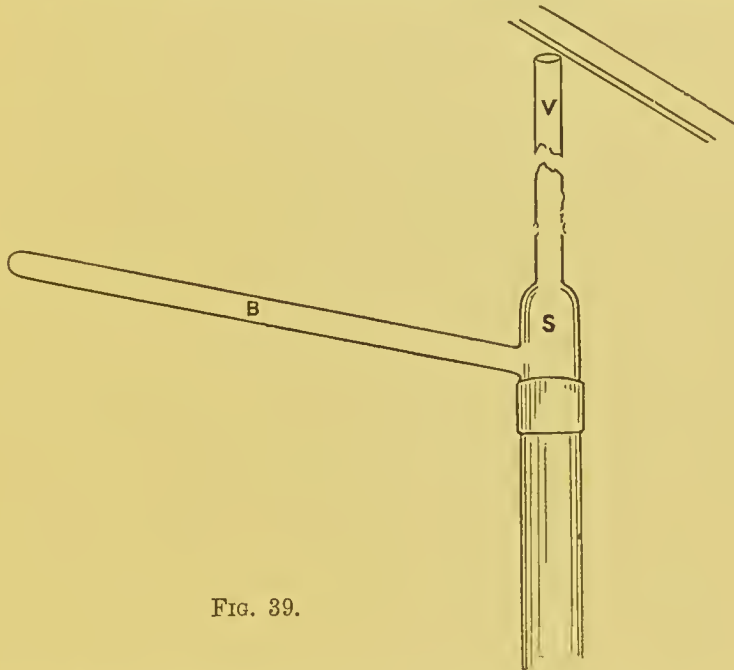
FIG. 39.

Fig. 39 represents a soil pipe and bath waste pipe, as seen from the outside, in a villa residence I lately examined. S is

the 4in. lead soil pipe jointed to an iron one; V is a 2in. ventilator, terminating just under the projecting edge of the roof; and B is a 2in. bath waste going direct to the soil pipe. Of

course, the bath waste pipe acted as a supplemental ventilator, ventilating the soil pipe into the bathroom.

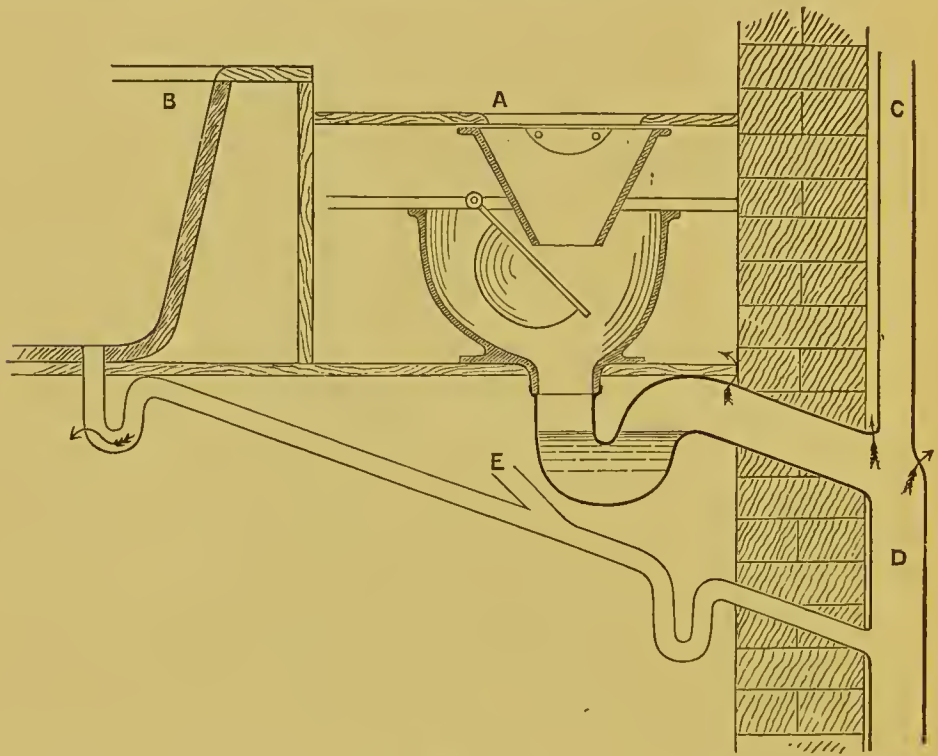
FIG. 41.

Fig. 41 shows the cause of an effluvium nuisance, which was most manifest near the bath. It was found that the trap under the bath was leaky, and an ineffectual attempt had been made to repair it with canvas, while the trap on the bath waste, next the wall, appeared to have been syphoned. A is the closet, B the bath, D a 4in. soil pipe, C is a 2½in. rain spout, made to act as a ventilator for the soil pipe, and E is a waste pipe from a urinal. As there was no trap between the sewer and the soil pipe, and the connections of the closet trap and soil pipe, and rain spout and soil pipe, were imperfect, sewer gas could escape into the bath and urinal, and at the points indicated by the

arrows in the illustration. That sewer gas actually did find its way into this house there is little doubt. A child died there, the cause of death being returned as "ulcerative pharyngitis;" and other inmates (mother and children) suffered from sore throats. Instead of complaining of the bad smell, attempts were made to smother it with carbolic powder, &c., and it was not till the death of the child that the attention of the sanitary authorities was directed to the house.

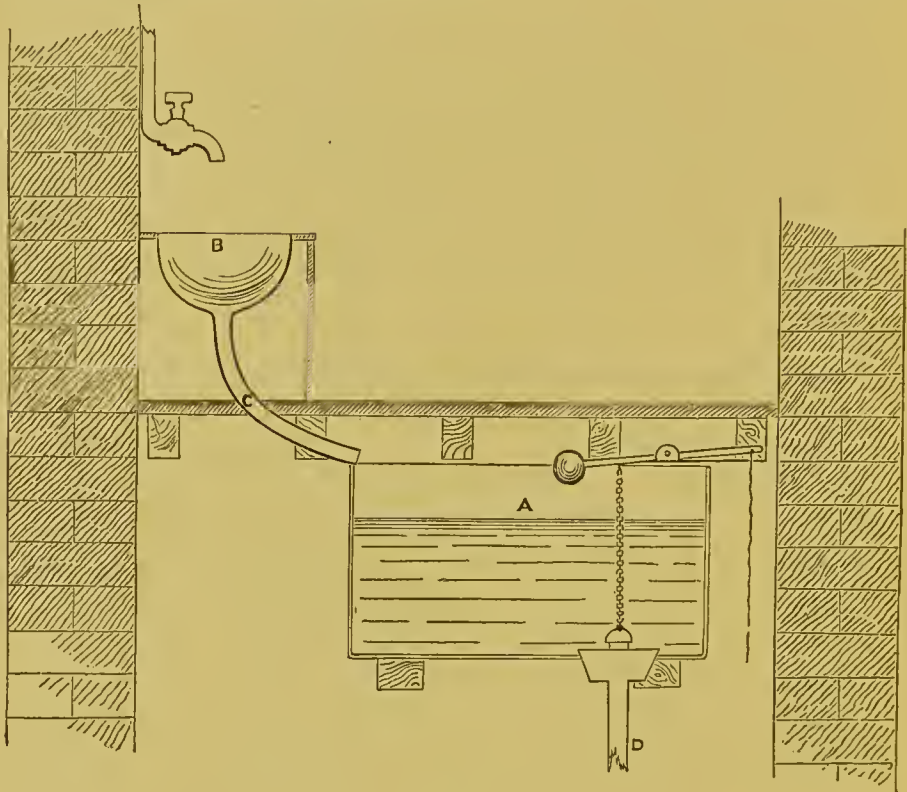
FIG. 44.

a villa residence he inspected. It seems strange how a plan so obviously objectionable came to be adopted. The sketch is reproduced in Fig. 44. A is a cistern serving the closet beneath, the cistern being supplied with rain water through a pipe not shown. B is a housemaid's sink, and C the waste pipe from the same, discharging into the cistern A. D is the pipe flushing the closet. An effluvium nuisance having arisen each time the closet was flushed, the apparatus was carefully examined, and it was then discovered that the closet was flushed, not with rain water only, as was supposed, but also with the slops daily thrown down the housemaid's sink.

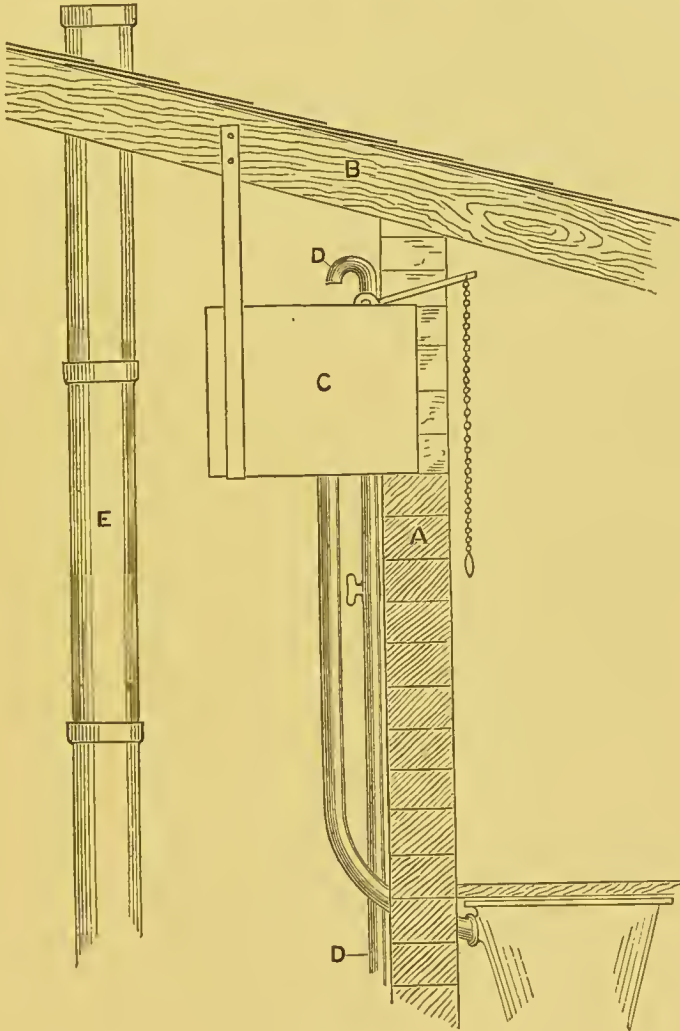
FIG. 45.

Fig. 45 shows how some midden privies were converted into dry ashpits and waterclosets. A hole was made in the wall A, just under the rafters B, large enough to admit the end of the cistern C. The cistern in each case was of light galvanised iron, 15in. by 6in., and 12in. deep. The whole of the cistern, excepting the small portion resting on the wall, is actually in the ashpit. Cisterns in such a situation are exceptionally liable to get foul, and are almost inaccessible. No overflow is provided, and the supply pipe D passes up a corner of the midden, through the ashes and refuse. The drain from the closet is ventilated (or, to be more correct, an exit for the drain air is provided) by means

of 4in. earthenware pipes E, built up the end wall of the middenstead, and delivering effluvia at a low level.

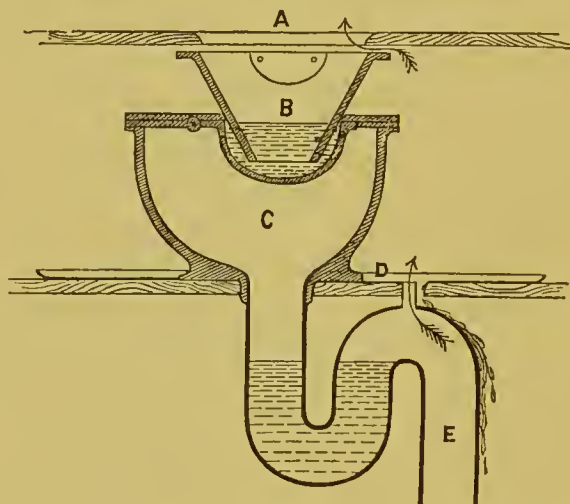
FIG. 48.

Fig. 48 represents a much more serious blunder on the part of a local plumber. The safe or tray to catch any foul water, &c., overflowing from the basin had been fixed, but in order to drain it a 1-in. pipe from the safe had been carried into the soil pipe. The

soldering of the top of this short pipe to the safe had given way, and it was found that the safe had been draining on the outside of the soil pipe. However, the foul air and gases in the soil pipe had ready access to the house, as shown by the arrows in the illustration. A is the closet seat, B the basin, C the container, D the safe, and E the soil pipe. The house in this instance was a very old one (rent about £40), and the closet fittings were old and worn.

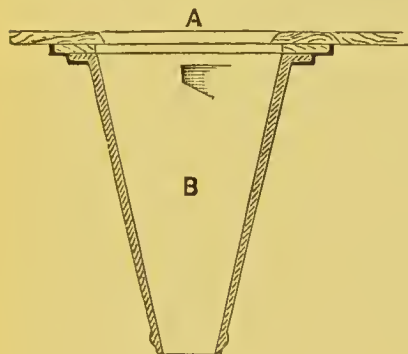
FIG. 49.

Fig. 49 shows in section a curious fixture, which, I think, cannot be very common. I can only describe it as a privy got up to look like a watercloset. A long earthenware basin B was screwed up to the underpart of the seat A, and the surface of the earthenware had become exceedingly foul. The quaint name was given it—"a dry watercloset."

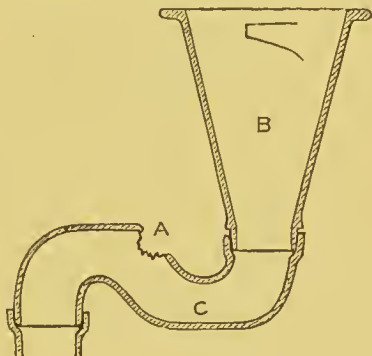
FIG. 50.

Fig. 50 represents a watercloset without water service, which was fitted in the yard of a cottage situated in a back court. On seeing there was no arrangement for flushing, I was surprised

the basin was not full, and I directed a further inspection, when it was found that a hole had been made in the top of the earthenware trap, which was jointed to the basin. I made particular inquiries as to this hole, and was told that "the man that fettled the thing, for fear it would get choked," made the hole—in other words, the hole was made that the contents of the pipe beyond might be pushed on with a stick, or otherwise. In the woodcut, B is the basin, C the earthenware trap, and A the hole referred to. As the hole was made on the drain side of the trap, it established a direct communication between the drain and the closet, which would have remained even if the trap had been kept charged with water.

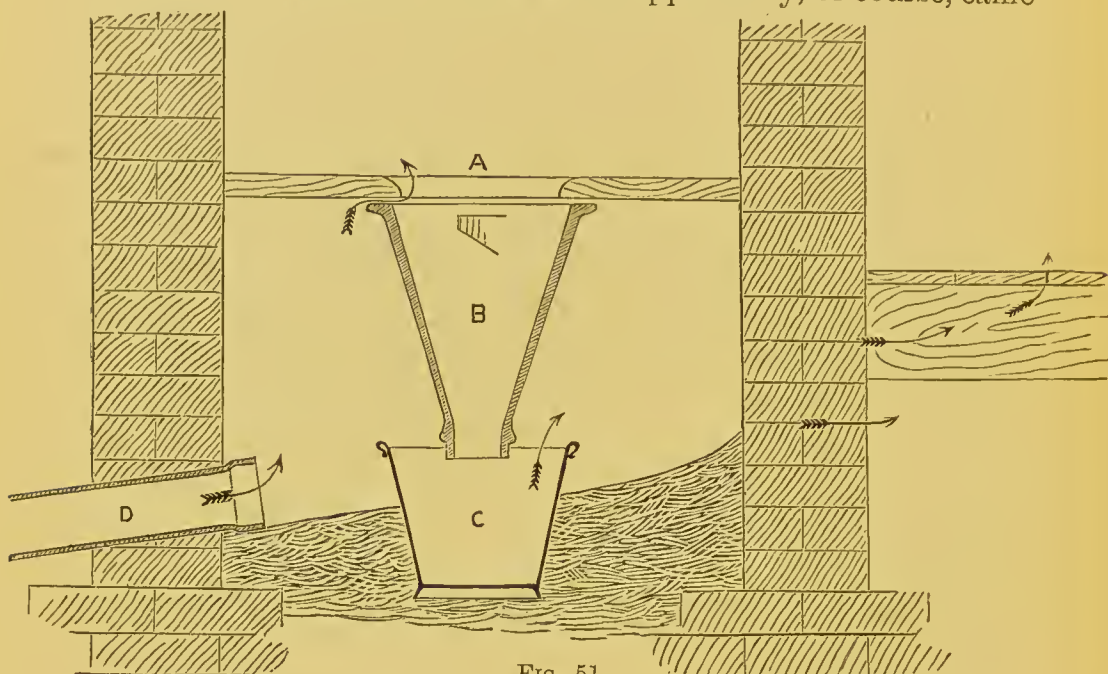
FIG. 51.

Fig. 51, sent me by a correspondent, represents a closet basin trapped into a galvanised iron bucket. The contents, of course, overflowed and found their way into the open drain shown to the left in the sketch. Next to this abominable closet was the kitchen, and the foul air and foul smells went through the joints

of a wall, almost destitute of mortar, and between the planks of the floor into the kitchen. The man who fitted this closet seems to have aimed at preventing the sewer gases from coming up the basin; but as the drain was untrapped they, of course, came

up without check external to the basin. The result of his contrivance was that he produced even a worse nuisance than if he had simply jointed the untrapped drain to the basin. A is the seat, B the basin, C the bucket, and D the drain.

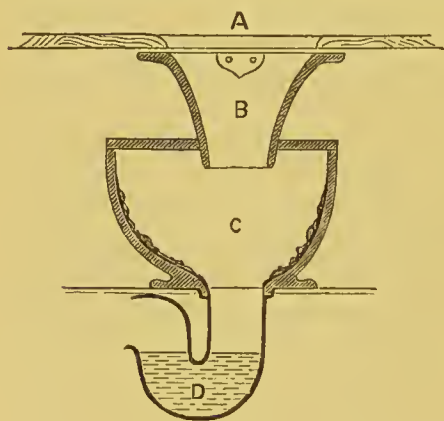
FIG. 52.

Fig. 52 shows an ordinary "pan" closet, which was fixed without a pan. The tenant had been in the house upwards of

a year, and told me the closet was as I found it from the first. If the pan had merely become broken off at the hinge it would have fallen, and probably caused an obstruction; if from any defect in the apparatus the pan could not recover its proper

position after flushing, it would have been hanging empty in the container. As it was, it was simply missing, and the plumber must have fixed the apparatus as I found it. The whole of the inner surface of the container, which was, of course, foul, was exposed, and a cause of more or less effluvium nuisance. A is the seat, B the basin, C the container, and D the trap.

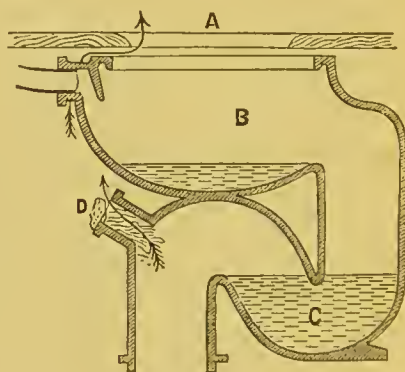
FIG. 53.

Fig. 53 indicates a danger from certain new forms of closets which had not occurred to me till the defect shown in the cut came under my attention. Many of these closets have an opening placed behind the trap for connecting a ventilator. The "National," the closet shown in section in the illustration, is thus contrived. It appears to be a good closet, and, if properly fixed and kept clean, is free from nuisance. However, very great nuisance was experienced from the particular closet I refer to, and, on uncovering it, it was found that the man who fixed the apparatus, instead of attaching a ventilator, filled up the hole where the ventilator should have been connected with *paper*, and covered this over at the top with putty. In course of time the putty loosened, and then the foul air from the soil pipe had ready access into the house. Of course, this foul air was rendered more foul by passing through a plug of paper saturated with the filth of years. A is the seat, B the basin, C the trap, and D the "stopped" vent hole.

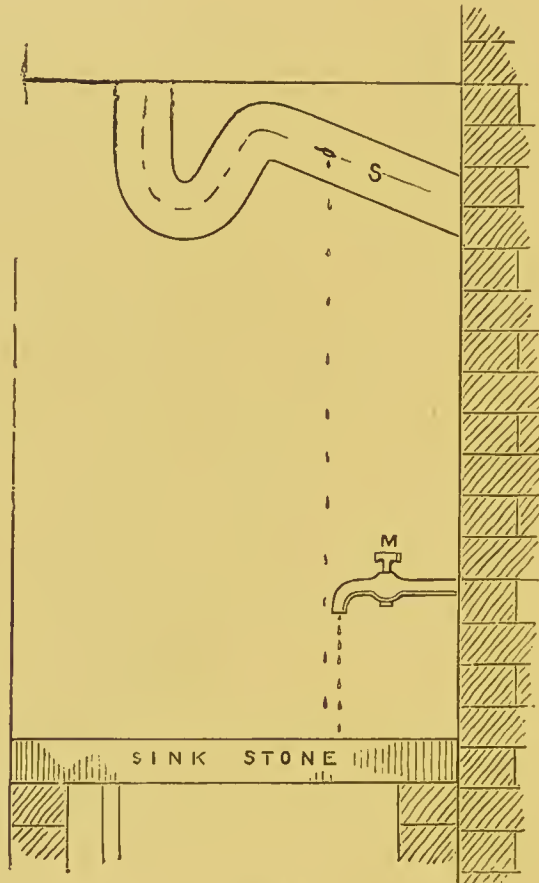
FIG. 57.

Fig. 57 is, I consider, one of the most interesting euts in this series, and I desire to draw speeial attention to it. I reeeived notice of a ease of typhoid fever in a very old house in a poor neighbourhood. The patient was forthwith removed to the fever hospital, and the usual report as to the state of the premises was submitted to me. From the latter I

gathered that the house was dirty, and that there was a water-closet built out from the back wall, a separate service cistern for the same, and a pipe from the main for drinking and domestic purposes. Not satisfied with this report, I examined the premises myself. I found the closet was entered from a small landing on the stairs, between the ground floor and first floor. On looking to see what was under this (on the ground floor), I was surprised to find a sink-stone, and a tap from the main. Immediately over the sink-stone was the lead trap from the closet and a transverse portion of soil pipe connected therewith, which was carried through the back wall into the house. In the soil pipe close to the trap was a corroded hole, the position of this being shown in the cut. Through this hole foul gases must often have been discharged, and foul liquids from the closet must often have overflowed. Indeed, here were all the conditions present which one would expect to find resulting in an outbreak of typhoid fever. What in all probability happened is that drinking water drawn from the tap was polluted with excremental liquid dropping into it, and that water thus polluted was actually drunk. The illustration indicates how easily a jug of water drawn from the main tap M might be polluted by foul liquid running from the hole in the soil pipe S.

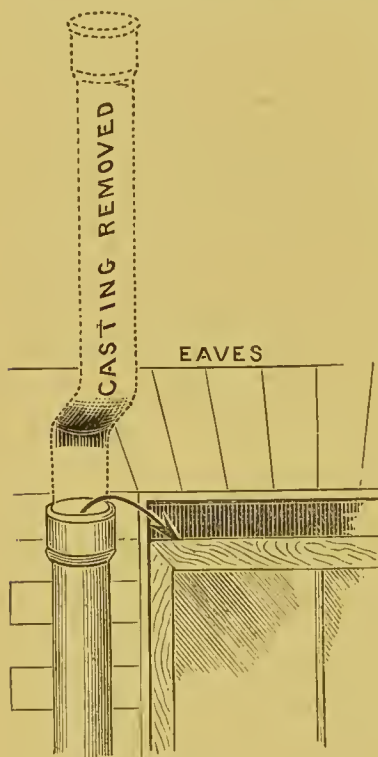
FIG. 58.

My attention was called to four houses where the soil pipe ventilators terminated close to back windows. In three cases the ends were on a level with the tops of the windows, and in one case a foot above the top. As the requirement with respect to soil-pipe ventilators is that they shall be carried up not less than 2ft. above the roof eaves, and the houses were quite new, special inquiries were instituted. Under the local Act, passed in 1881, it is "not lawful to let or occupy as a dwelling-house any building, not so used before the commencement of the Act, until

such building has been certified by the surveyor, or other officer appointed for the purpose, to be as to drainage, supply of water for domestic purposes, and in every other respect fit for human habitation, and constructed and completed in conformity with the provisions of the Act and the local bye-laws." It transpired that these four houses were submitted to examination, the soil pipe ventilators then terminating as required 2ft. above the roof eaves, and were duly certified fit for human habitation. How-

ever, shortly afterwards other houses approached completion, and iron eastings necessary to carry the ventilators 2ft. above the roof eaves not being ready to hand, those belonging to the four houses already certified were removed, and made to do duty in obtaining a certificate for other houses. When the houses thus robbed were visited, three were occupied, and in each of these three the window next the soil pipe end was open for two or

three inches at the top. The accompanying illustration (Fig. 58) explains itself.

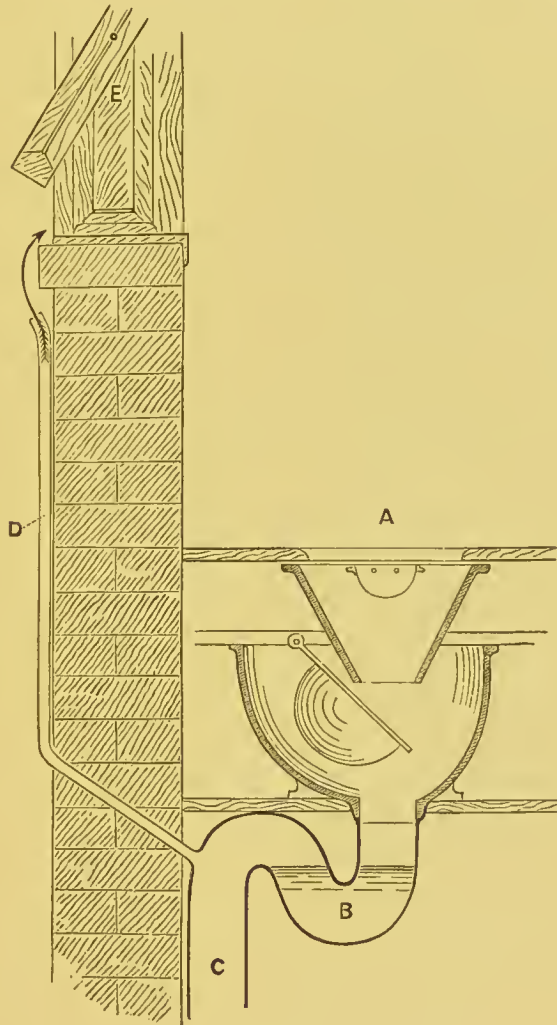
FIG. 59.

Fig. 59 represents an old pan closet which, although placed next an external wall, delivers into a soil pipe carried down inside the house. The closet A delivers into a lead syphon trap B, which is continuous with the soil pipe C. The soil pipe is connected with an earthenware pipe drain running under the

be drawn into the closet whenever the swing window happens to be open. In the figure the ventilator is represented as a $\frac{3}{4}$ in. instead of a 1 in. pipe.

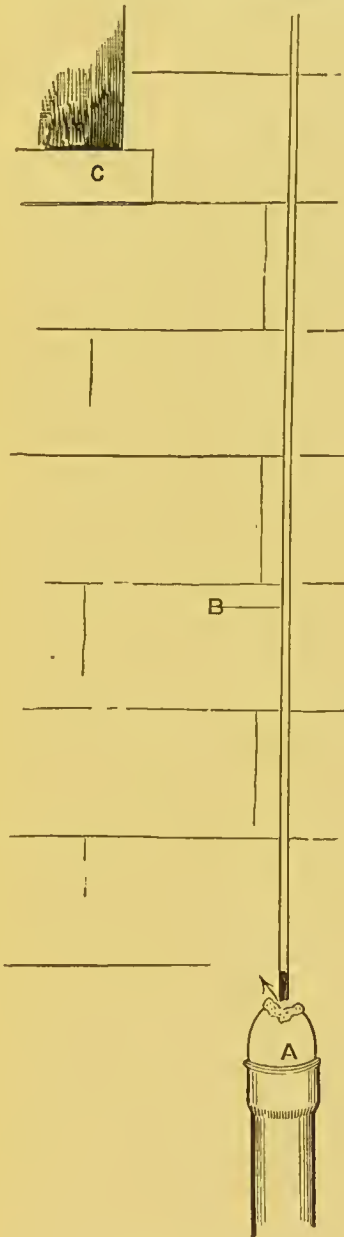
FIG. 61.

Fig. 61 shows a "ventilator" to a soil pipe which I discovered at a large suburban house. It was put up with the approval of the local surveyor and medical officer. A 4in. lead soil pipe was brought through the wall and efficiently connected with an iron soil pipe. A large hole had then been made in the lead at the top, and a $\frac{1}{2}$ in. iron pipe connected to this hole with putty. The iron pipe was quite closed up at the lower end with rust, &c., and was just too short to meet the lead pipe. Through a large hole in the lead and putty, effluvia ascended to the window 5ft. above. A is the lead pipe, B the "ventilator," and C the window.

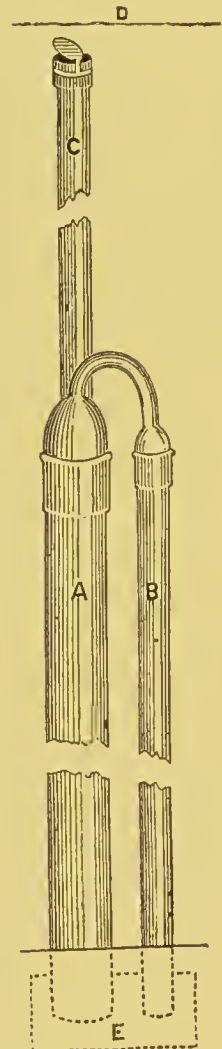
FIG. 63.

Fig. 63 shows how the soil pipe and bath waste in a large semi-detached house were brought down from an upper storey and ventilated. The 4in. iron soil pipe was ventilated with a 2in. iron pipe, terminating just under the roof eaves, and capped with a little metal top, as if purposely to direct any foul air emitted towards a window a few inches off. The 2in. iron bath waste came out by the side of the soil pipe, and was connected with it (for what purpose I know not) by a 1in. lead pipe, as shown. A is the soil pipe, B the bath waste, C the soil pipe ventilator, D the roof eaves, and E the chamber into which soil pipe and bath waste delivered, and through which the contents were transmitted to the 6in. pipe under the house. Taking a soil pipe and bath waste out separately, and afterwards connecting them together, above and below, seems an unusually ridiculous proceeding.

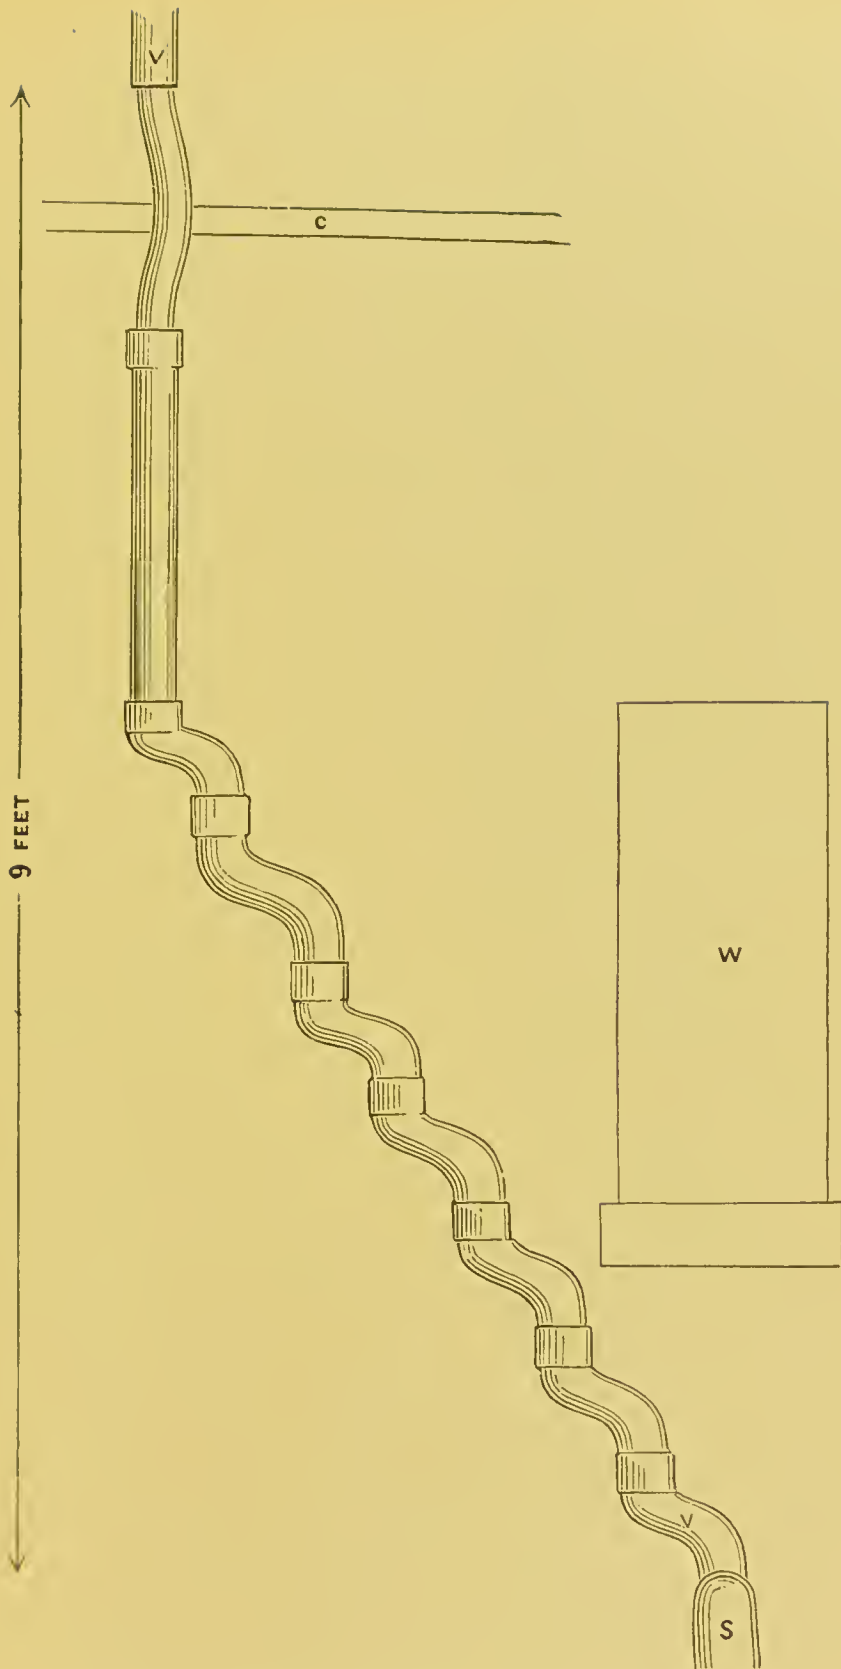
FIG 64.

A correspondent has kindly drawn my attention to a soil pipe ventilator which is certainly noteworthy. Such an unworkman-like contrivance I hope and believe is not common. (*Vide* Fig. 64, which is carefully drawn to scale.) W represents the window

of a closet, and S the lead soil pipe from same. Jointed to this was an iron pipe easting, which carried the ventilator up nine inches; and next to this came a second, third, and fourth casting of the same size; and then three more eastings similar in shape and averaging the same length. Above this was $2\frac{1}{4}$ ft. of iron pipe, then the rain gutter C had to be "jumped," and there was a further length of about 8 ft. of iron pipe, the ventilator terminating a few inches above the top of the gable. It will thus be seen that the ventilator VV, in ascending 9 ft., had no less than ten joints. It is not likely that all these joints were tight in the first instance, and quite impossible that they would remain so after the expansions and contractions of a few summers and winters. Two windows, one above the other, to the left,

were in close proximity to these joints. It is to be noted that while the soil pipe is 4 in. in diameter the curved castings are 3 in. pipes, and above a smaller diameter pipe is used. My correspondent remarks that the plumber responsible for this work was probably uninformed on the subject of resistance to air currents by friction, and that he sacrificed efficiency to a taste for ornamental device and the desire to sell as much piping as possible.
